State of California — The Resources Agency
DEPARTMENT OF PARKS AND RECREATION
PRIMARY RECORD

Page 1 of 1 *Resource name(s) or number (assigned by recorder) 718 Bailey Street

*P11. Report Citation: (Cite survey report and other sources, or enter "none") Heritage Napa: Soscol Gateway/East Napa Historic Resource Survey

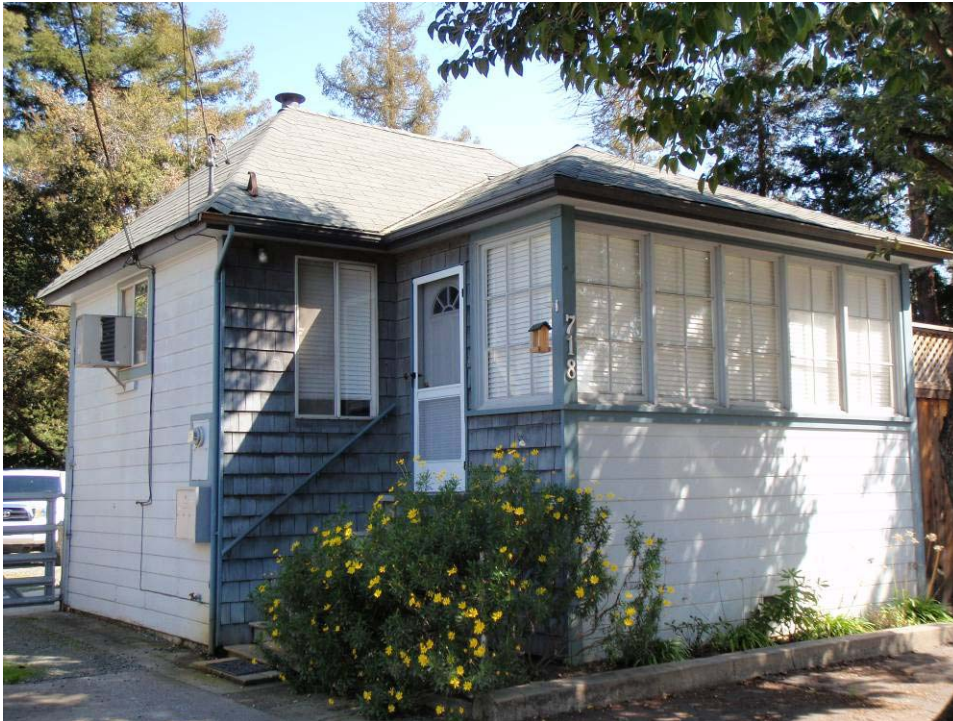
718 Bailey Street is located on a rectangular lot on the east side of Bailey Street between 3rd and 4th streets. It is located adjacent to the Napa Valley Expo grounds to the east and south. Built in 1910, 718 Bailey Street is a 1-story over raised basement, wood frame, single-family residence designed in a vernacular cottage style. The building is L-shaped in plan, clad in wood shiplap siding and wood shingles, and capped by a hip roof. The primary facade faces west and features a projecting bay, which appears to be an inclosed porch on the south. The primary entry is located on the north side of this projecting bay and is approached by wood steps. The entrance is a paneled wood replacement door with a lunette window in the upper portion. Typical fenestration consists of sliding aluminum-sash replacement windows with six and nine-pane wood-sash casement windows enclosing the porch. Architectural features include corner boards. The roofline features shallow boxed eaves. A gravel driveway spanned by a metal gate is located on the north side of the house and provides access to a parking area at the rear of the lot. The building appears to be in good condition.

*P5b. Photo: (view and date)
Primary and north façades,
looking southeast from Bailey St.
3/24/2009

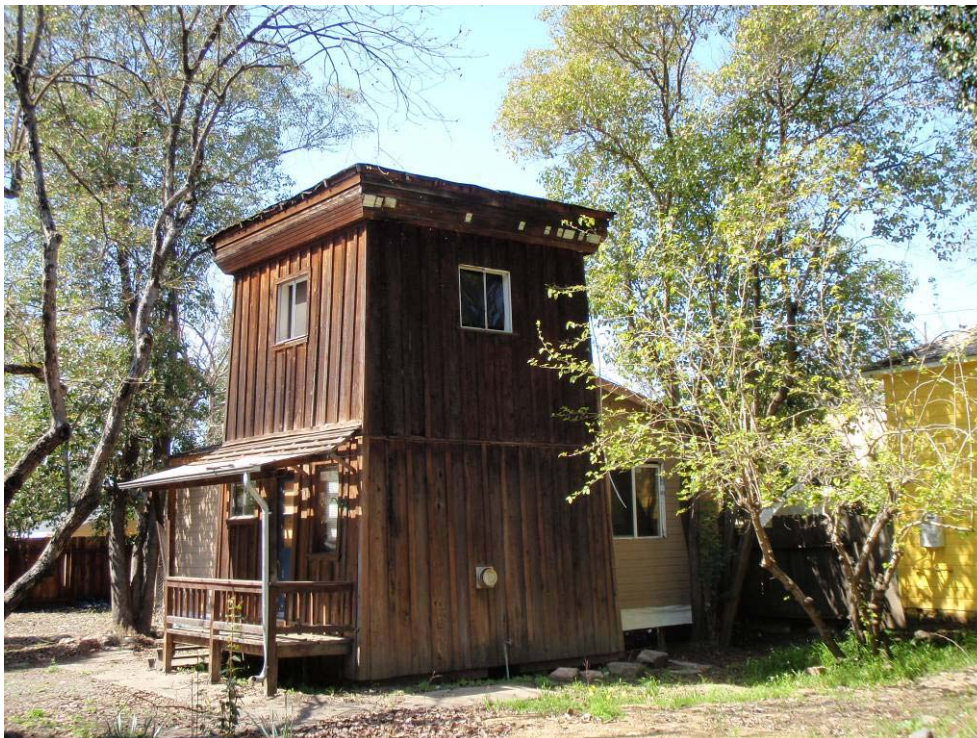
719 Bailey Street is located on a rectangular lot on the west side of Bailey Street, between 3rd and 4th streets. Built in 1915, 719 Bailey Street is a 2-story, wood frame, water tower that has been converted into a single-family residence and is designed in a utilitarian style. The building is irregular in plan as a result of multiple additions on the north side. It is clad in wood board-and-batten and wood shiplap siding, and capped by flat and shed roofs. The foundation is not visible. The primary facade faces south and features an entry porch that spans the width of the water tower. The porch is accessed by wood steps on the west and features wood railings and square posts that support a shed roof. The primary entrance, at the center of the façade, is a partially-glazed, flush wood door with flat board trim. Typical fenestration consists of sliding, aluminum-sash windows. The roofline of the water tower features a boxed cornice-like element clad with wood beadboard, and exposed rafter tails. The additions feature open eaves. The front of the lot is enclosed by a chain link fence. The building appears to be in fair condition.

P5b. Photo: (view and date)
Primary and east facades,
looking west from Bailey Street
3/24/2009

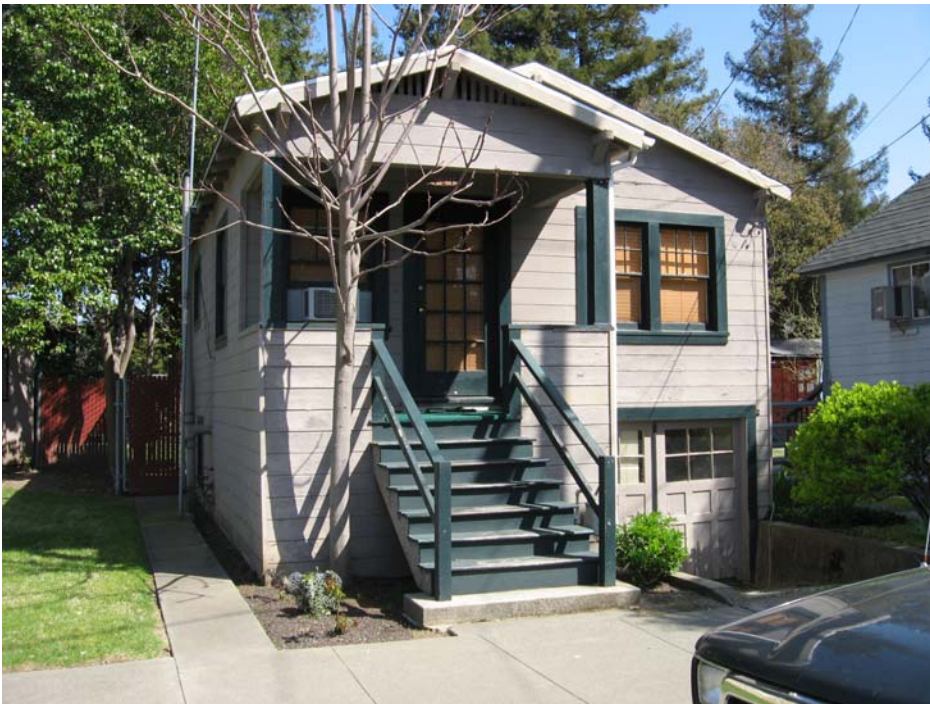
724 Bailey Street is located on a narrow rectangular lot on the east side of Bailey Street between 3rd and 4th streets. It is located adjacent to the Napa Valley Expo grounds to the east. Built circa 1915, 724 Bailey Street is a 1-story over raised basement, wood frame, single-family residence designed in the Craftsman style. The building is rectangular in plan, clad in wood shiplap siding, and capped by a gable roof. The foundation is not visible. The primary facade faces west and features a porch on the north side. The porch is approached by wood stairs with wood railings and features a solid railing and square posts supporting a gable roof. The primary entry is located within the porch, near the center of the façade, and consists of a fully-glazed, multi-pane, wood door with flat board trim. Typical fenestration consists of six-over-one and one-over-one, double-hung, wood-sash windows with flat board trim. Architectural features include an integral garage at the basement level that has hinged, partially-glazed, paneled wood double doors, and is accessed by a paved sub-grade driveway. The roofline features open eaves with exposed rafter tails, eave brackets, narrow barge boards, and wood slat attic vents in the gable ends. The rear of the lot is inclosed by a chain link fence with vinyl slats. The building appears to be in good condition.

P5b. Photo: (view and date)
Primary facade, looking east
from Bailey St.
3/24/2009

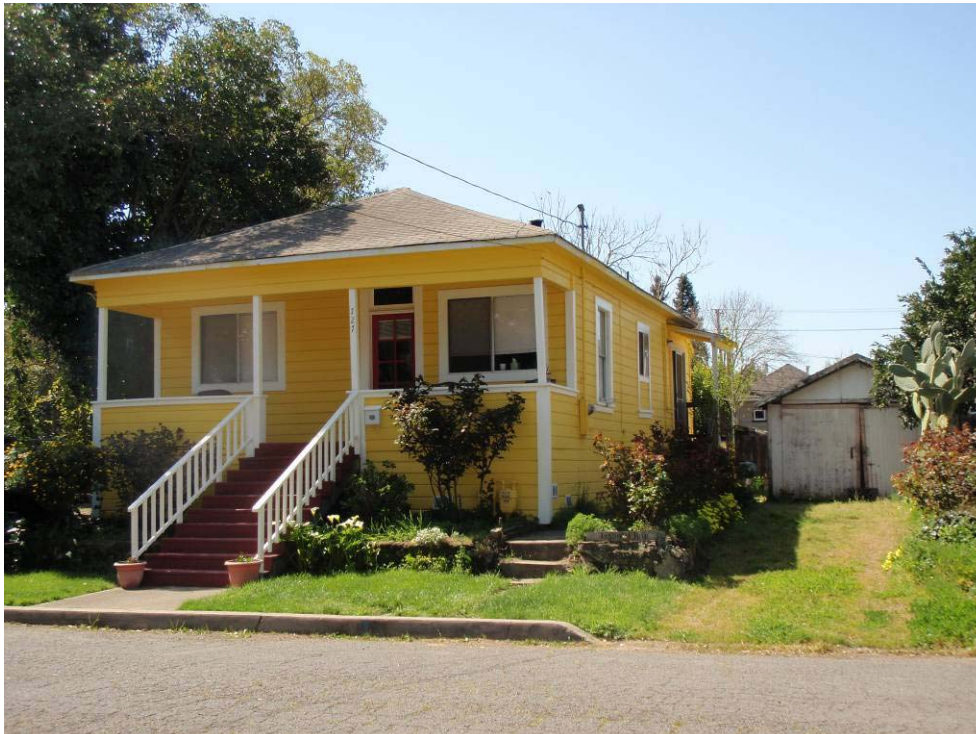
*P3a. Description: (Describe resource and its major elements. Include design, materials, condition, alterations, size, setting, and boundaries.)
727 Bailey Street is located on a rectangular lot on the west side of Bailey Street, between 3rd and 4th streets. Built in 1918, 727 Bailey Street is a 1-story, wood frame, single-family residence designed in the Simple Bungalow style. The building is rectangular in plan, clad in wood shiplap siding, and capped by a hip roof. The foundation is not visible. The primary facade faces east and features a full-width entry porch. The porch is accessed by wood steps with wood railings and features a solid railing and wood posts that support the overhang of the main roof. The primary entrance, located near the center of the façade, is a fully-glazed, wood door with a glazed transom and flat board trim. A shed-roofed portico and secondary entry are located on the north facade. Typical fenestration consists of sliding and double-hung, aluminum-sash replacement windows with flat board trim. Architectural features include corner boards. The roofline includes a plain frieze and shallow boxed eaves. An unpaved driveway to the north of the building leads to a detached gable-roofed garage at the rear of the lot. 727 Bailey Street appears to be in good condition.

P5b. Photo: (view and date)
Primary and north façades,
looking west from Bailey Street
3/24/2009
